Simplesat-1 Experiment Final Report

David R. Skillman, P.I. Laser Remote Sensing Branch 4 March 2002

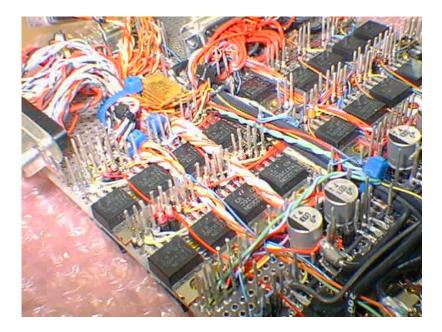
Simplesat-1 Experiment Final Report Flight Electronics Design and Construction

- Power distribution board (left), I/O expansion board (right)
- Two circuit boards needed to glue commercial components together
- All electronics designed, built, and tested by P.I.

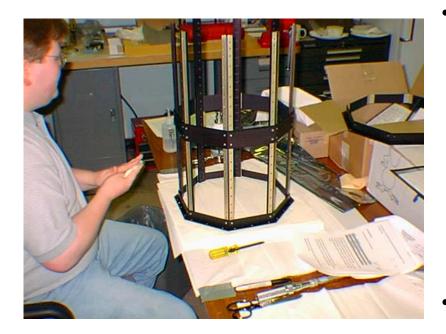
Simplesat-1 Experiment Final Report Mechanical Design and Construction

- Detailed design by 4th year U. Md.
 undergrad in Mechanical Engineering
 - all aluminum no composites or exotic materials
 - full Pro Engineer CAD/CAM model created
 - Autocad drawings of parts provided to local commercial fab houses
 - full certs obtained for all materials, processes, and coatings
- Baseplate validation with HitchHiker hardware early in cycle

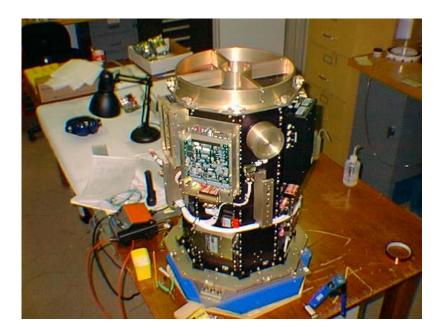
Simplesat-1 Experiment Final Report Mechanical Assembly

- Spacecraft early assembly
 - computer
 - reaction wheel
 - battery box
 - GPS receiver
 - RF equipment
 - cabling
 - secondary mirror assembly
 - entrance window
 - baseplate (19" dia)
 - overall height 26"
